Personal Home Inspection of
1 Elm Court
Anywhere, NJ 08888

Personal Home Inspection

Report # 16700

Date of Inspection: Thursday March 27, 2008

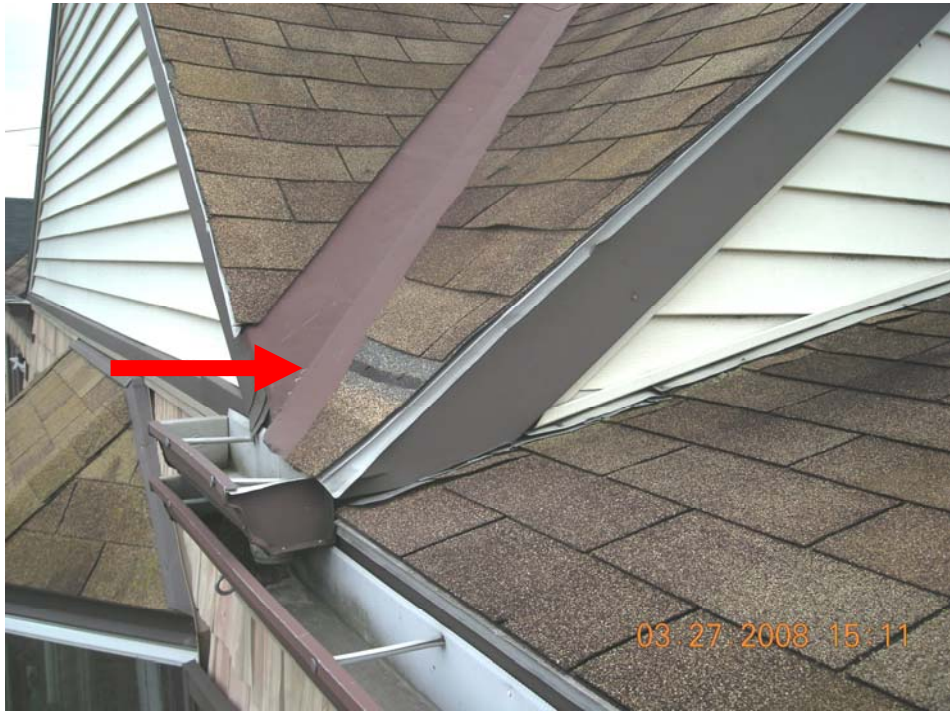
**EXHIBIT 1
(Roof – Missing Shingle)**

One shingle is missing at front. Plan to replace missing shingle in the near future to prevent water seepage and/or damage. Some shingle popping noted at rear. Resecure shingles to prevent water seepage and/or damage. See Attached Exhibits 1 & 2.

Asphalt shingle roofing in satisfactory overall condition, except as noted. One shingle is missing at front. Some shingle popping and lifting noted at rear. Resecure lifting shingles to avoid water penetration and damage. Some roofing is losing granules and wearing as typical of this type and age roof. Asphalt shingle roofing of this quality and type has an expected economic lifespan of 18-25 years.

Plan to replace missing shingle in the near future to prevent water seepage and/or damage. Periodically check and reseal all flashing at vent pipes, chimney and all roof siding joints to reduce chance of leaking. Roof vent pipes in satisfactory condition.

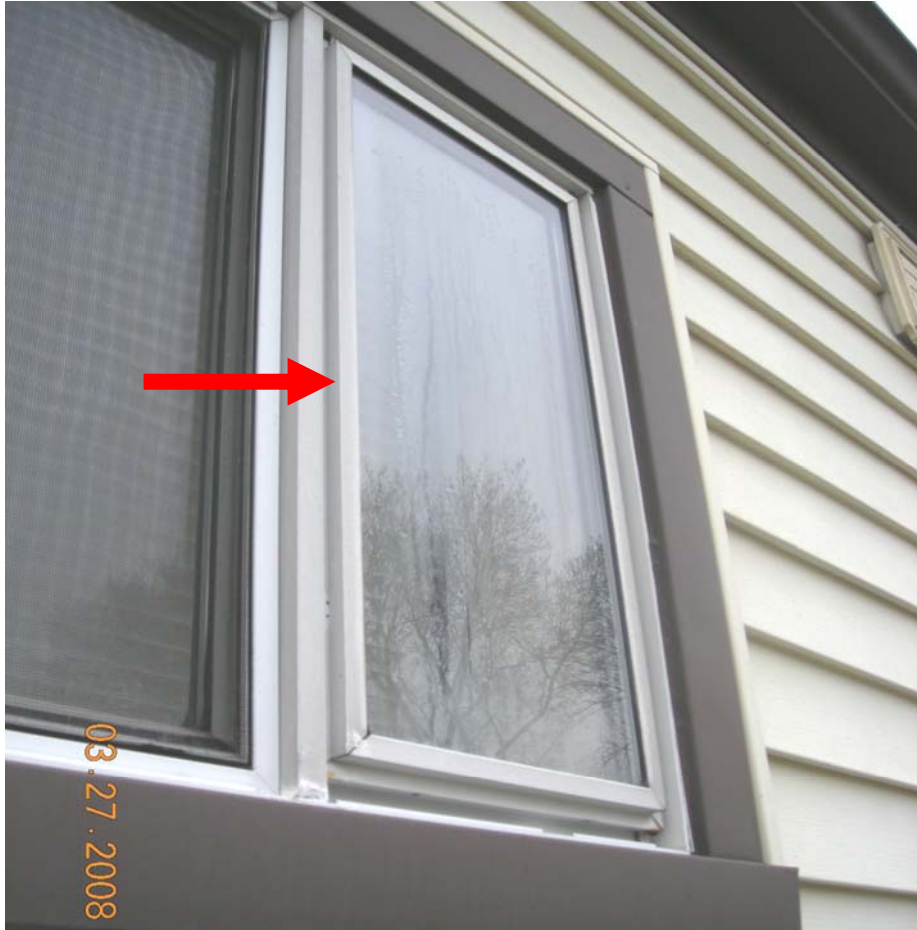
**EXHIBIT 3
(Window – Broken Seal)**

Some screens are damaged. Repair or replace screens as required. Seal is broken on double-glazed windows at rear. Seal is broken on one double-glazed door at rear. Fading and/or moisture noted between window panes. Broken seals result in the loss of transparency due to moisture and fading in window. Degradation of the thermal insulation qualities will be affected. Recommend that windows be repaired and/or replaced as required. Due to the design and noted defects, the possibility exists that additional seals may break in the future. See Attached Exhibits 3, 4 & 5.

Double-glazed thermopane windows with screens throughout house. Some screens are damaged. Repair or replace screens as required. Double-glazed thermopane sliding doors at rear. Seal is broken on double-glazed windows at rear. Seal is broken on one double-glazed door at rear. Fading and/or moisture noted between window panes. Broken seals result in the loss of transparency due to moisture and fading in window. Degradation of the thermal insulation qualities will be affected. Recommend that windows be repaired and/or replaced as required. Due to the design and noted defects, the possibility exists that additional seals may break in the future. Screen and storm door at front entrance noted. Inventory screens during pre-closing inspection.

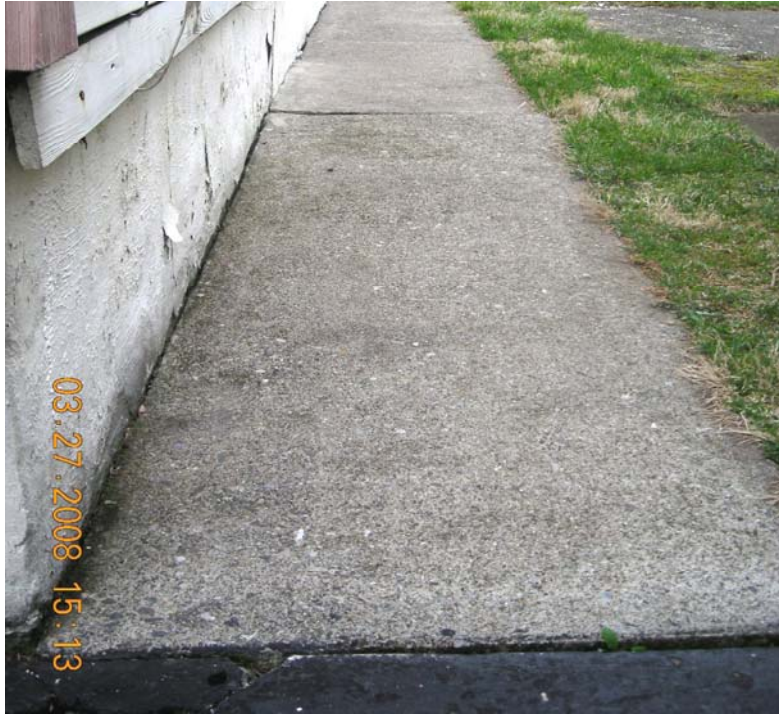
EXHIBIT 6
(Sidewalk – Slope Toward House)

Walks have settled moderately in areas, especially at side. Walk slopes toward house slightly at side; expect accumulation and/or seepage. Seal along foundation or, if necessary, correct situation to prevent accumulation and/or seepage. Asphalt driveway has settled and cracked moderately in areas. Plan to repair and seal driveway in the near future to maintain level and firm surface, integrity and prolong service life. See Attached Exhibit 6.

Concrete walks are in satisfactory overall condition, except as noted. Walks have settled moderately in areas, especially at side. Walk slopes toward house slightly at side; expect accumulation and/or seepage. Seal along foundation or, if necessary, correct situation to prevent accumulation and/or seepage. Asphalt driveway noted. Driveway has settled and cracked moderately in areas. Plan to repair and seal driveway in the near future to maintain level and firm surface, integrity and prolong service life. Periodically seal driveway to maintain integrity and extend service life.

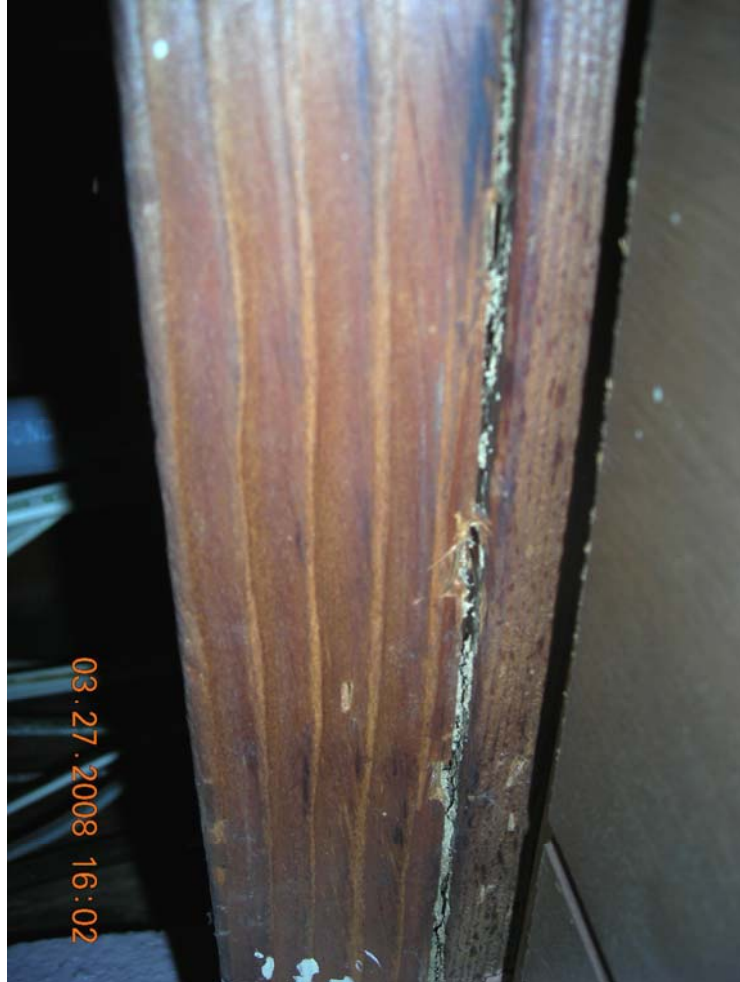
EXHIBIT 7
(Wood Destroying Insect Tubes – Girder)

Wood destroying insect mud tubes noted in girder on right side. Recommend further investigating around affected areas, if possible, to determine if any damage exists. See Attached Exhibit 7.

Most of basement is finished. Wall and floor conditions were not determinable in these areas. Block walls are in overall satisfactory condition, where observable. Framing was unobservable in most areas due to finished basement. Joists are in overall satisfactory condition, where visible. Girders are in overall satisfactory condition, where visible. Wood destroying insect mud tubes noted in girder on right side. Recommend further investigating around affected areas, if possible, to determine if any damage exists. Due to design of footings, if any, condition is undeterminable. Jersey Building Inspections, Inc. is not responsible for any damage due to wood destroying insects that is not visible by inspector. Recommend termite company determine damage, if any.
