Personal Home Inspection of  
1 Elm Court  
Anywhere, NJ 08888

Report # 16700

Premises Inspected: 1 Elm Court  
Anywhere, NJ 08888

Date of Inspection: Thursday March 27, 2008

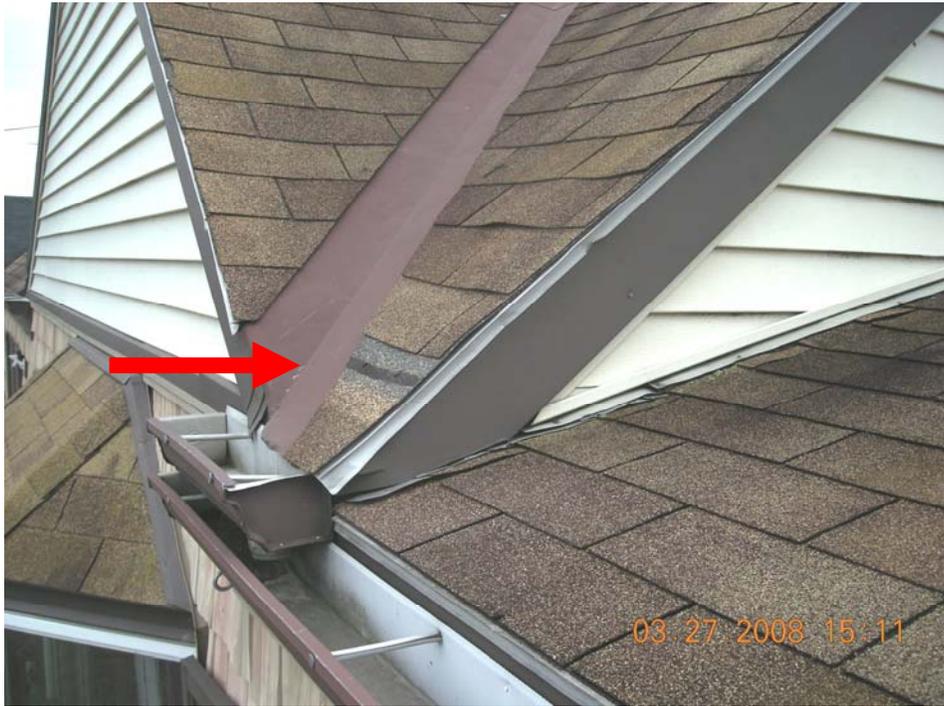
One shingle is missing at front. Plan to replace missing shingle in the near future to prevent water seepage and/or damage. Some shingle popping noted at rear. Resecure shingles to prevent water seepage and/or damage. See Attached Exhibits 1 & 2.

**EXHIBIT 1  
(Roof – Missing Shingle)**

Asphalt shingle roofing in satisfactory overall condition, except as noted. One shingle is missing at front. Some shingle popping and lifting noted at rear. Resecure lifting shingles to avoid water penetration and damage. Some roofing is losing granules and wearing as typical of this type and age roof. Asphalt shingle roofing of this quality and type has an expected economic lifespan of 18-25 years.

Plan to replace missing shingle in the near future to prevent water seepage and/or damage. Periodically check and reseal all flashing at vent pipes, chimney and all roof siding joints to reduce chance of leaking. Roof vent pipes in satisfactory condition.

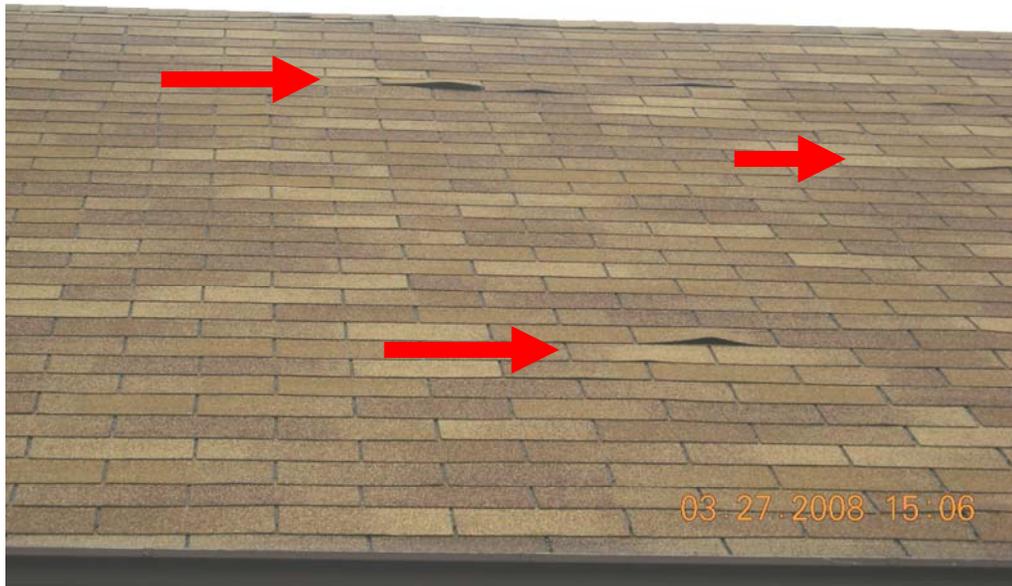
**EXHIBIT 2  
(Roof – Shingle Popping/Lifting Shingles)**

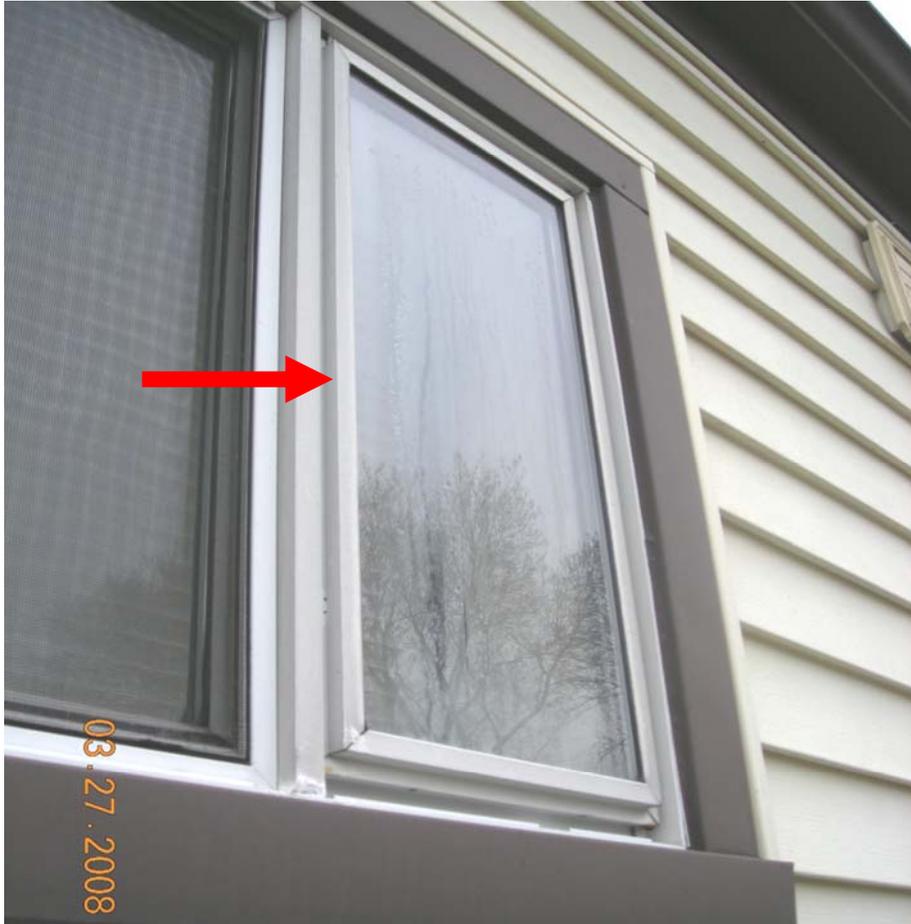
Some screens are damaged. Repair or replace screens as required. Seal is broken on double-glazed windows at rear. Seal is broken on one double-glazed door at rear. Fading and/or moisture noted between window panes. Broken seals result in the loss of transparency due to moisture and fading in window. Degradation of the thermal insulation qualities will be affected. Recommend that windows be repaired and/or replaced as required. Due to the design and noted defects, the possibility exists that additional seals may break in the future. See Attached Exhibits 3, 4 & 5.

EXHIBIT 3  
(Window – Broken Seal)

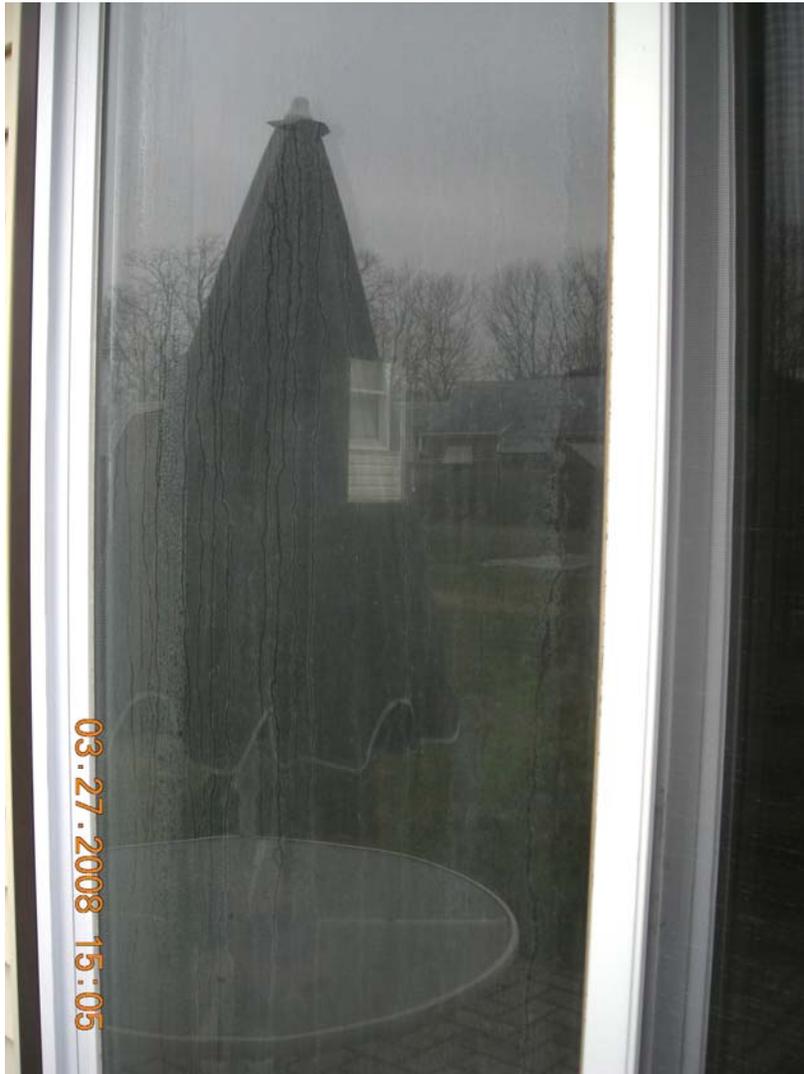
EXHIBIT 4  
(Sliding Door – Broken Seal)

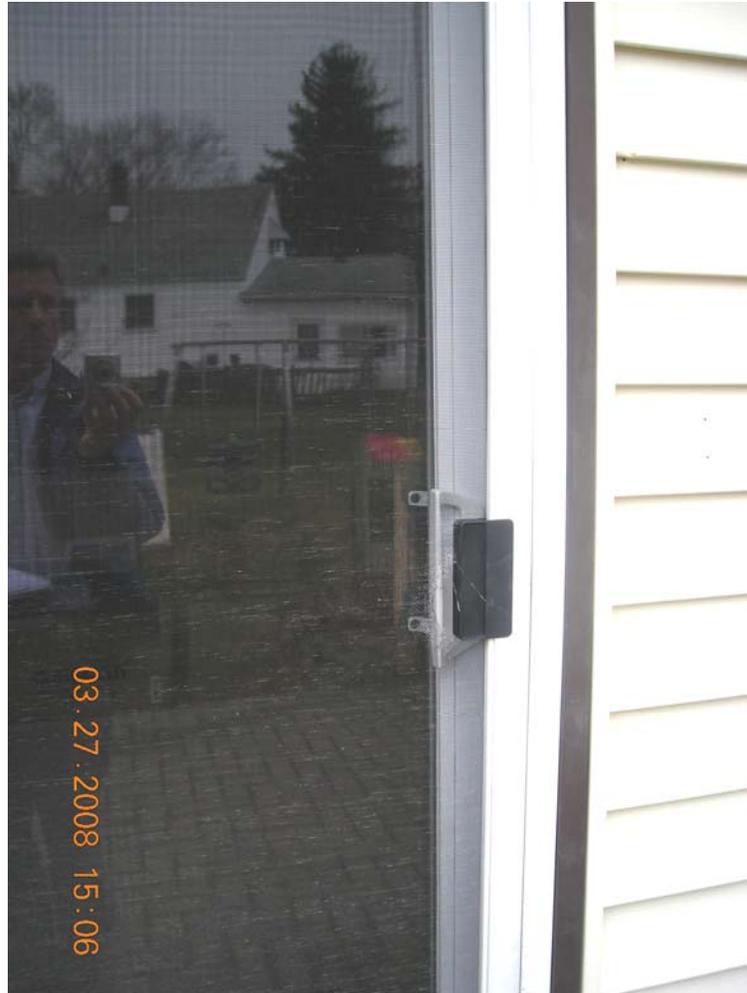
**EXHIBIT 5  
(Sliding Door – Broken Seal)**

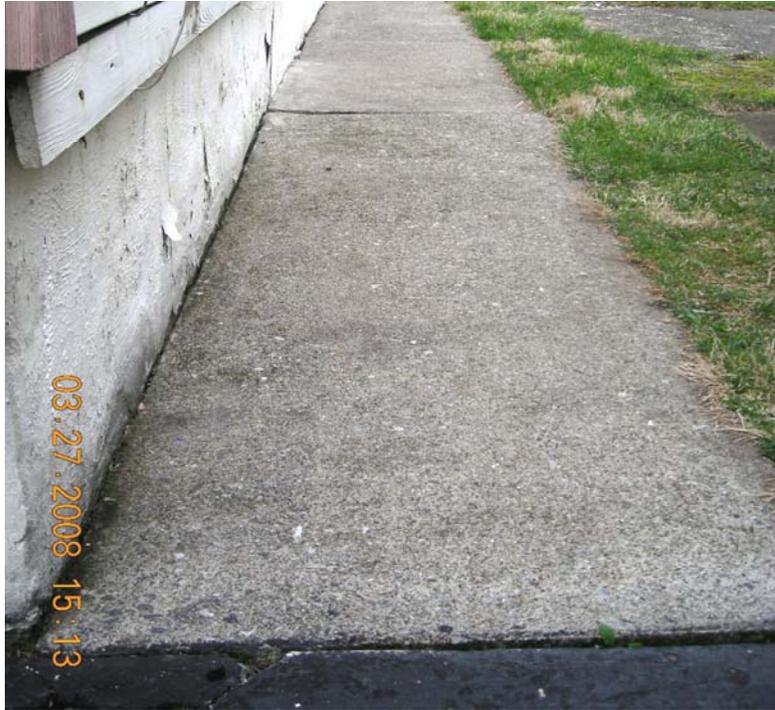
Walks have settled moderately in areas, especially at side. Walk slopes toward house slightly at side; expect accumulation and/or seepage. Seal along foundation or, if necessary, correct situation to prevent accumulation and/or seepage. Asphalt driveway has settled and cracked moderately in areas. Plan to repair and seal driveway in the near future to maintain level and firm surface, integrity and prolong service life. See Attached Exhibit 6.

**EXHIBIT 6**  
(Sidewalk – Slope Toward House)

Concrete walks are in satisfactory overall condition, except as noted. Walks have settled moderately in areas, especially at side. Walk slopes toward house slightly at side; expect accumulation and/or seepage. Seal along foundation or, if necessary, correct situation to prevent accumulation and/or seepage. Asphalt driveway noted. Driveway has settled and cracked moderately in areas. Plan to repair and seal driveway in the near future to maintain level and firm surface, integrity and prolong service life. Periodically seal driveway to maintain integrity and extend service life.

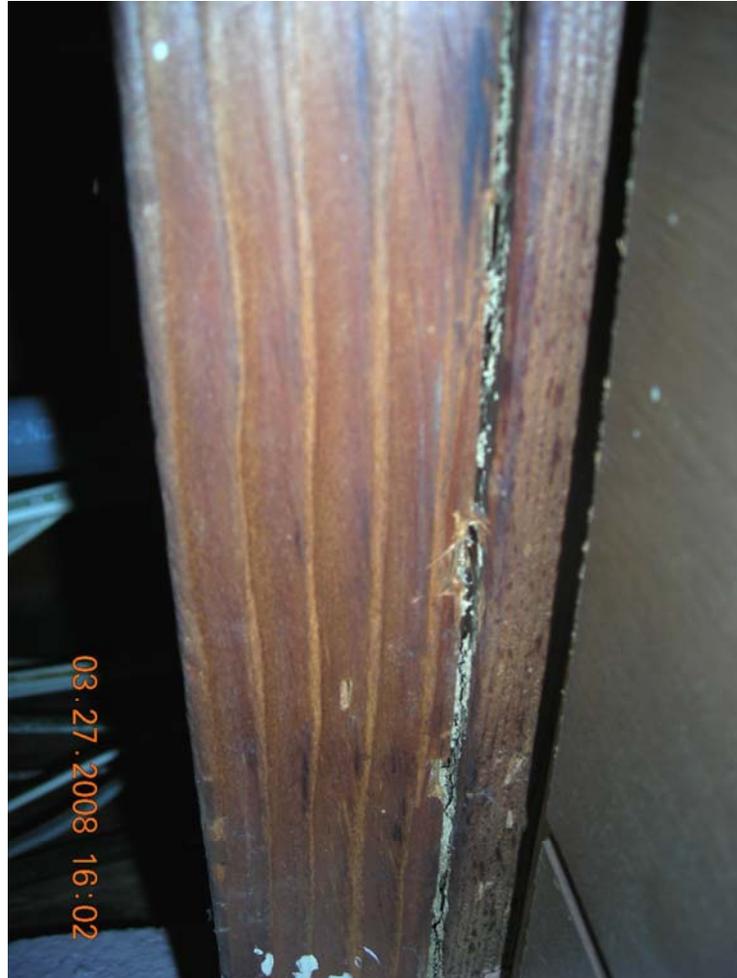
Wood destroying insect mud tubes noted in girder on right side. Recommend further investigating around affected areas, if possible, to determine if any damage exists. See Attached Exhibit 7.

EXHIBIT 7  
(Wood Destroying Insect Tubes – Girder)

Most of basement is finished. Wall and floor conditions were not determinable in these areas. Block walls are in overall satisfactory condition, where observable. Framing was unobservable in most areas due to finished basement. Joists are in overall satisfactory condition, where visible. Girders are in overall satisfactory condition, where visible. Wood destroying insect mud tubes noted in girder on right side. Recommend further investigating around affected areas, if possible, to determine if any damage exists. Due to design of footings, if any, condition is undeterminable. Jersey Building Inspections, Inc. is not responsible for any damage due to wood destroying insects that is not visible by inspector. Recommend termite company determine damage, if any.
